# *The Solid Scoop*

*December 2014*

A Newsletter for the Southern  
Calif. Chapter of the Solid  
Axle Corvette Club

Vol. 10 Number 4

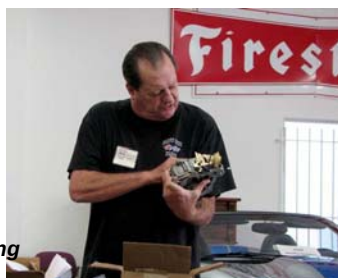
Left, Chip indicates how ethanol gasoline has corrosively ate away the inside of a one-of-a-kind carb. In the accelerator pump area causes excessive leaking. This mainly is caused by water absorption and non-use of the car. Prevention of this can be by adding Automatic Transmission fluid (1/2 oz. per gal of gas) at each tank fill-up.

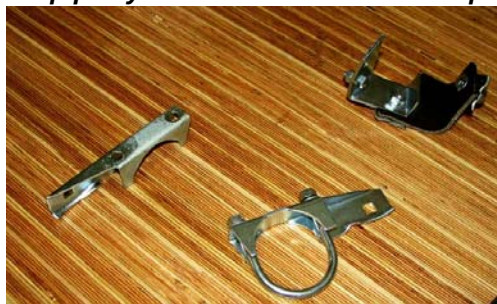
(Top & Bottom) Special clamp for '57 - '60 Vettes where exhaust extends through rear bumper.

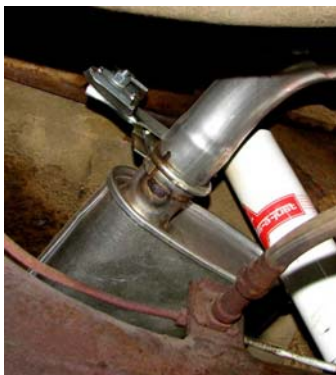
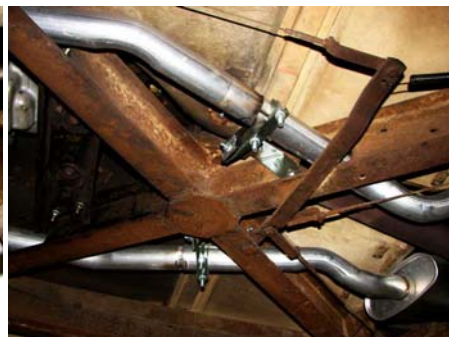
Exhaust pipes "snaking" through the center X-member.

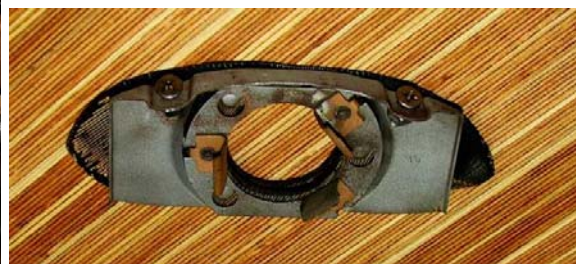
It should be noted in the drawing the wiper/contact to the variable resistor is mechanically connected to a float which floats on the fuel within the tank.

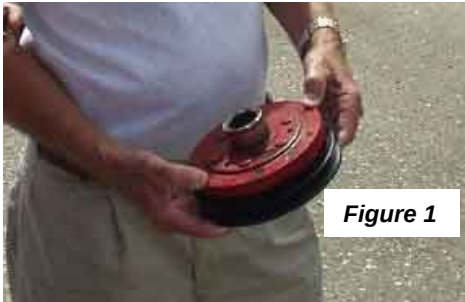
Figure 1

This situation is what happened when my Harmonic Balancer (HB) fell off the crankshaft on my 1957 Corvette, while driving on the highway. Luckily it didn't damage anything. The HB can be seen in Figure 1.

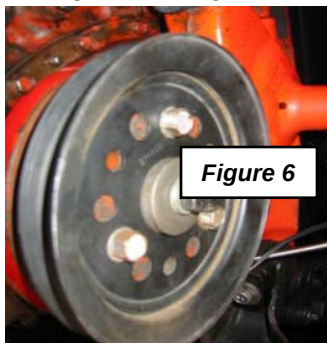
Figure 6

Once the crankshaft is threaded, tap the balancer gently onto the crank to get it started and draw it into place making sure that you have at least 3/8" thread engagement at all times don't strip your new threads. (see fig 6)

Fig 6 shows the balancer in place with the new bolt, lock washer and retaining washer.
